Case 356 : Narrative

| Case Vehicle (A): 2002 Oldsmobile | Vehicle (B): 1993 White/GMC/Volvo |
| Type: Silhouette, 4-door minivan | Type: Tractor-trailer |

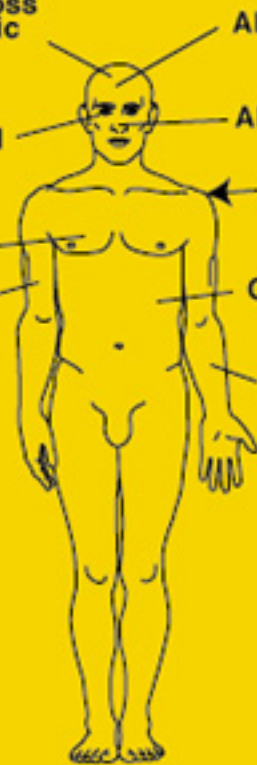
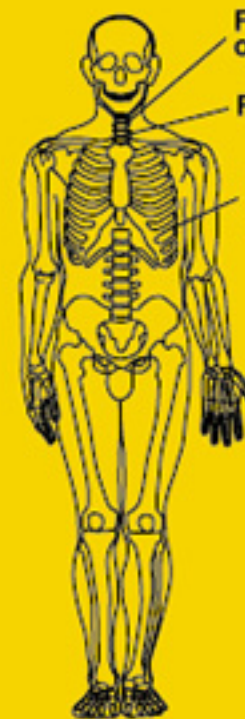
Grade 3 laceration, spleen (3)

Contusion, left forearm (1)

Fracture, spinous process of C6 (2)

Fracture, left lamina of C7 (3)

Fractures, left ribs #10, #11, and #12 (2)

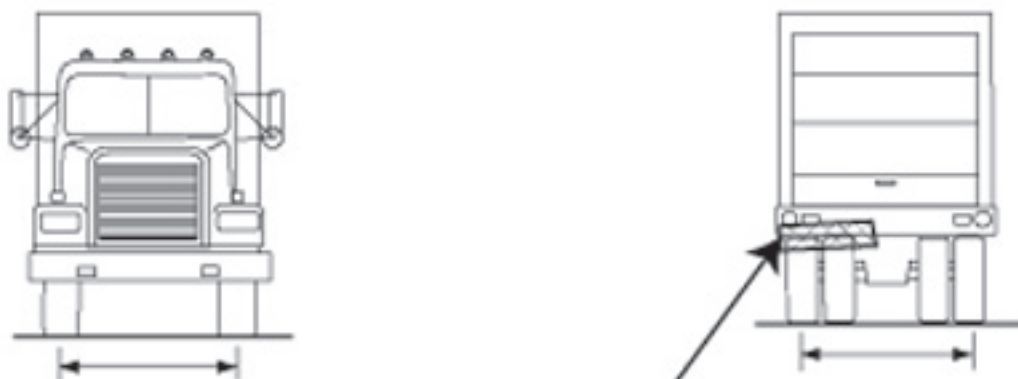
Not inspected - one on-scene photo only

direct damage to underride bar only

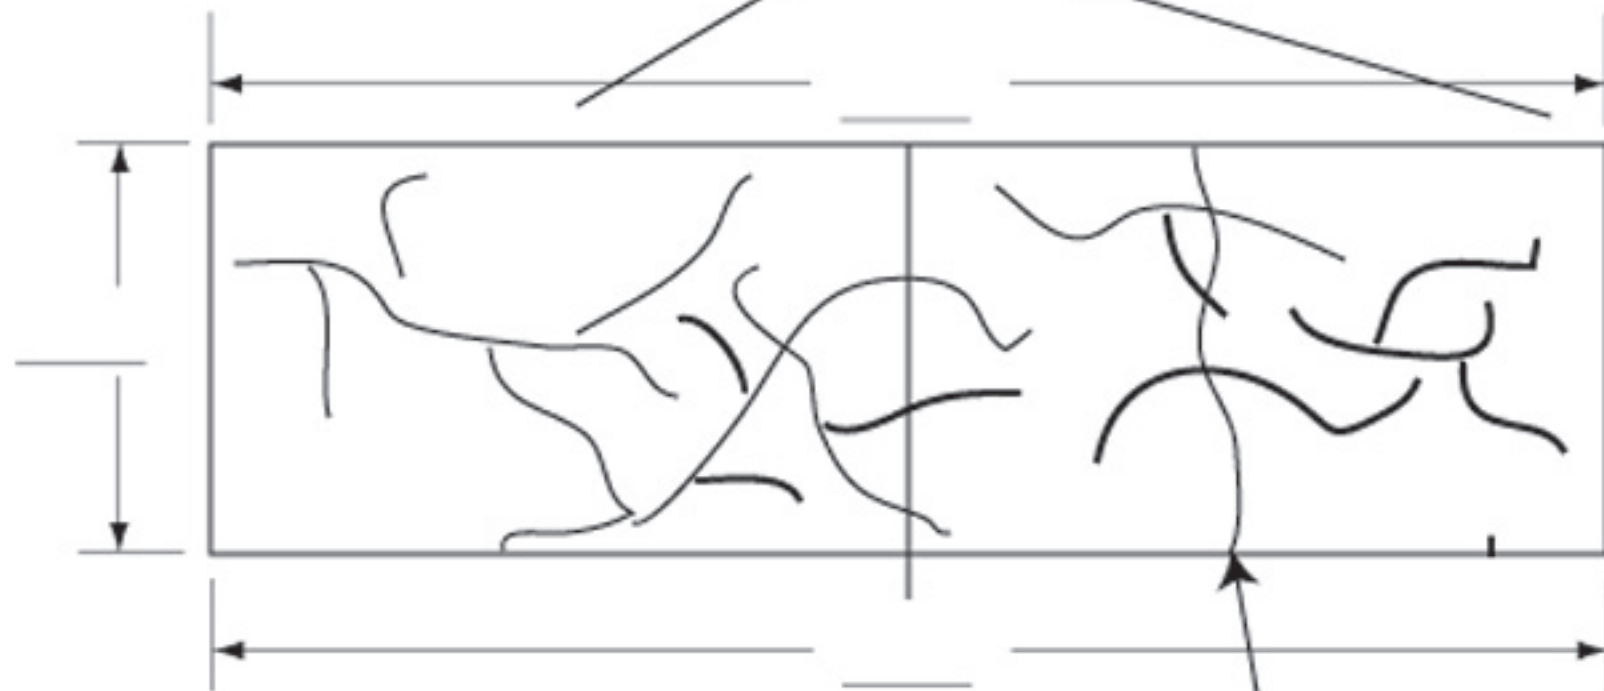
WINDSHIELD MARK ON CASE VEHICLE:

Unable to read W/S mark

Bond separation along top edge

**WS plastic innerlayer torn
due to Vehicle B penetration**

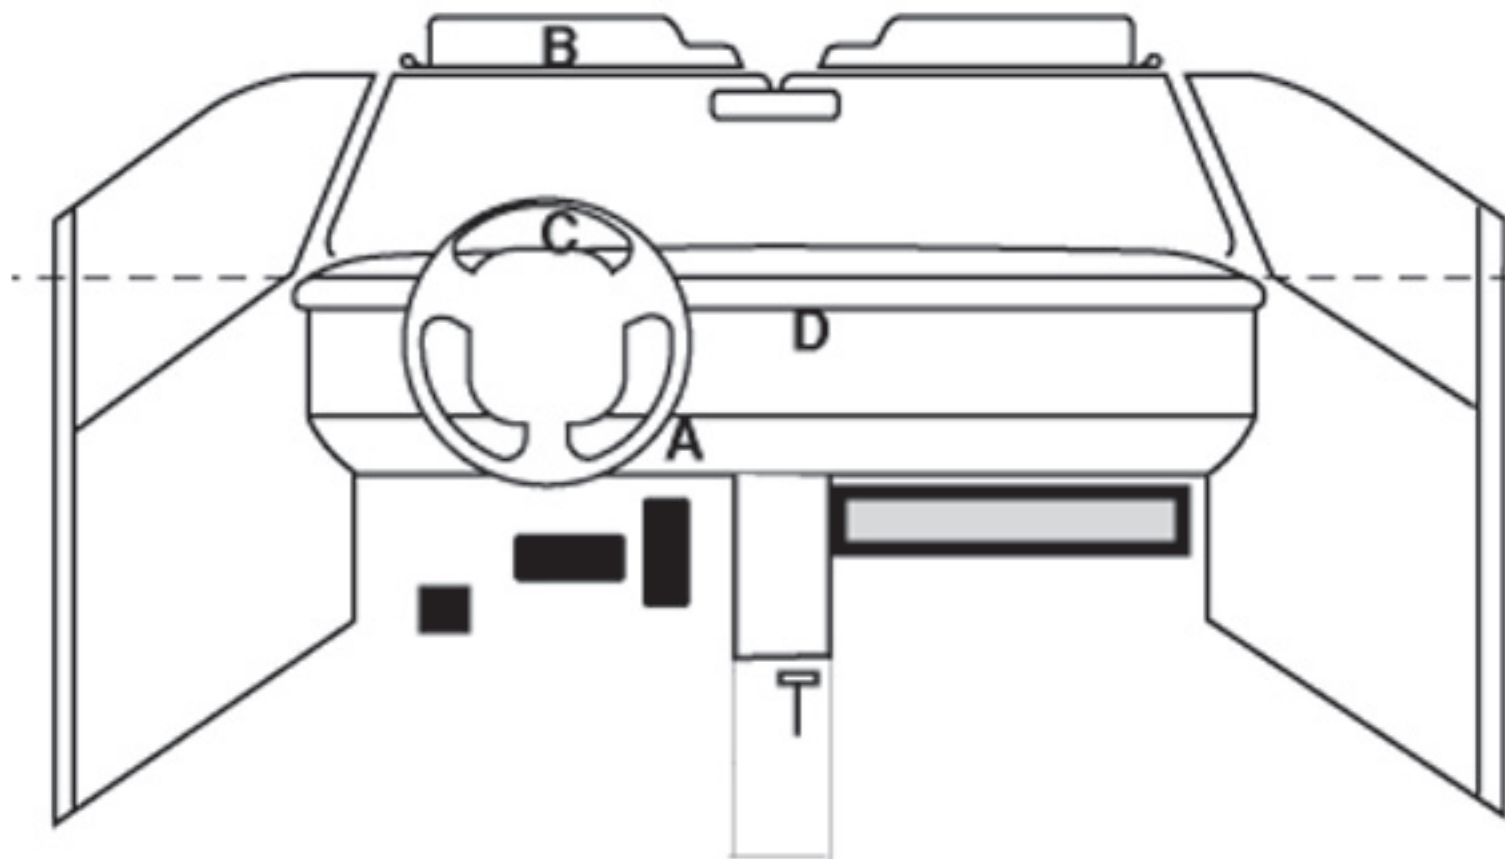
A = knee bolster, cloth transfer

B = W/S header and visor, scuff mark with hair

C = upper IP - instrument shroud, blood stain

D = center IP - air vent, blood stain
